CONOR FUREY & ASSOCIATES LTD
Consulting Engineers and Project Managers

ENGINEER'S SURVEY REPORT

2nd Hand House Survey

Inspected on: - 7th July 2013

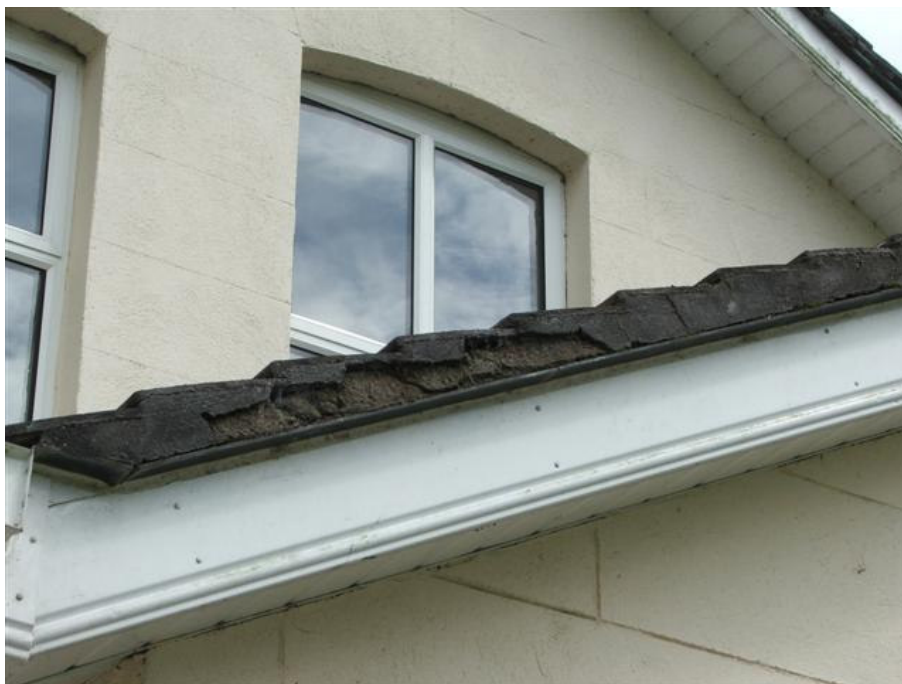
Roof tiles are complete. Bedding mortar at the verges of the porch are in need of repair. Proprietary ridge systems are complete. There are no cracked or slipped tiles. The roof covering is free from mortar. The line is even and the gauge is correct.

Photo 1: Showing bedding mortar missing from eaves of porch.

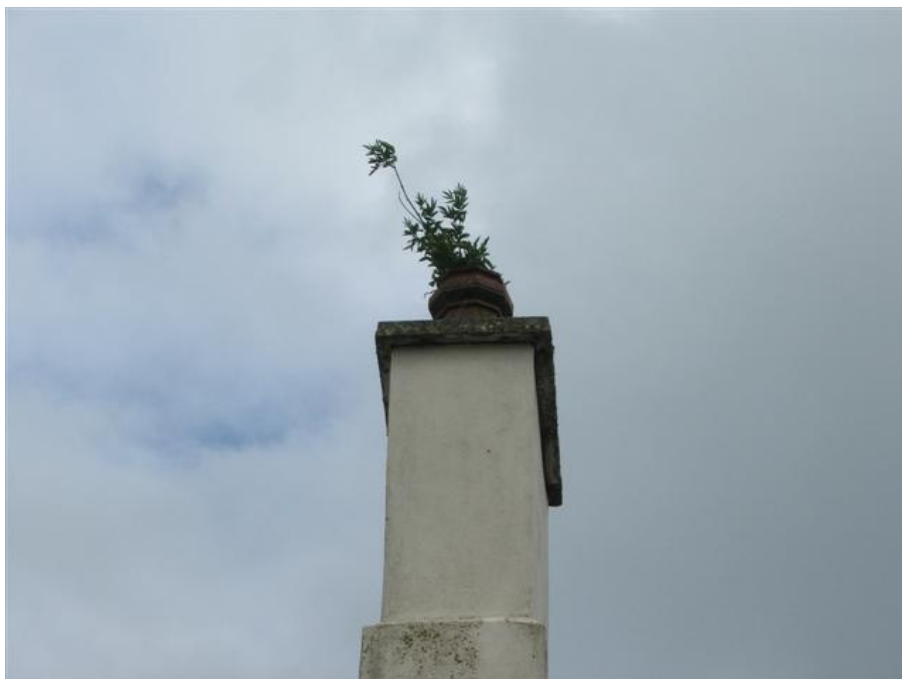
Flashings are correctly installed, wedged and pointed up. There is evidence of vegetation growing within the chimney stack this must be addressed, see attached photo.

Photo 2: Showing vegetation in chimney.

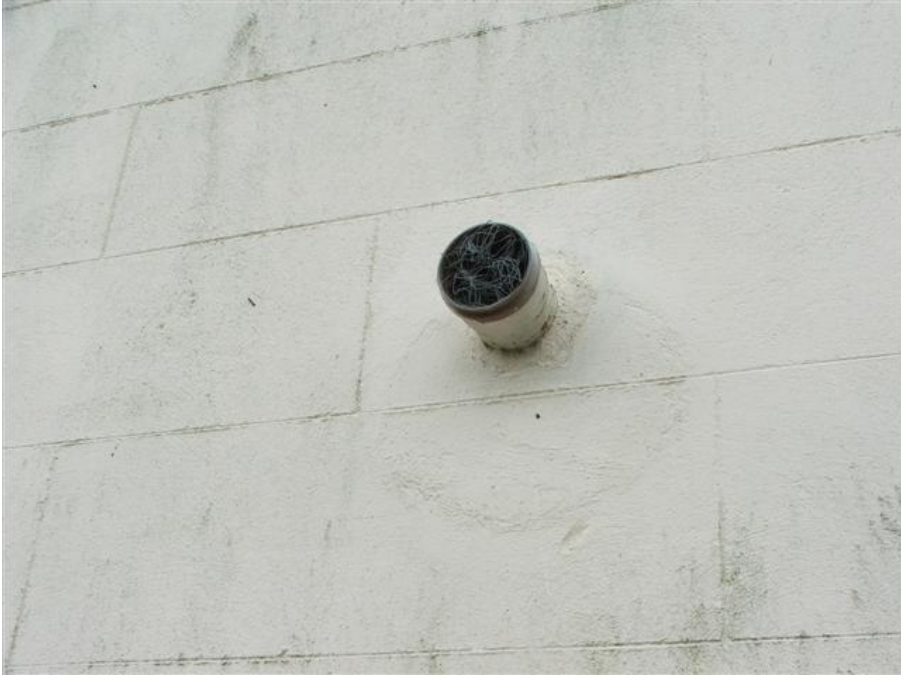
Photo 3: Showing poor finish to extract vent from kitchen.

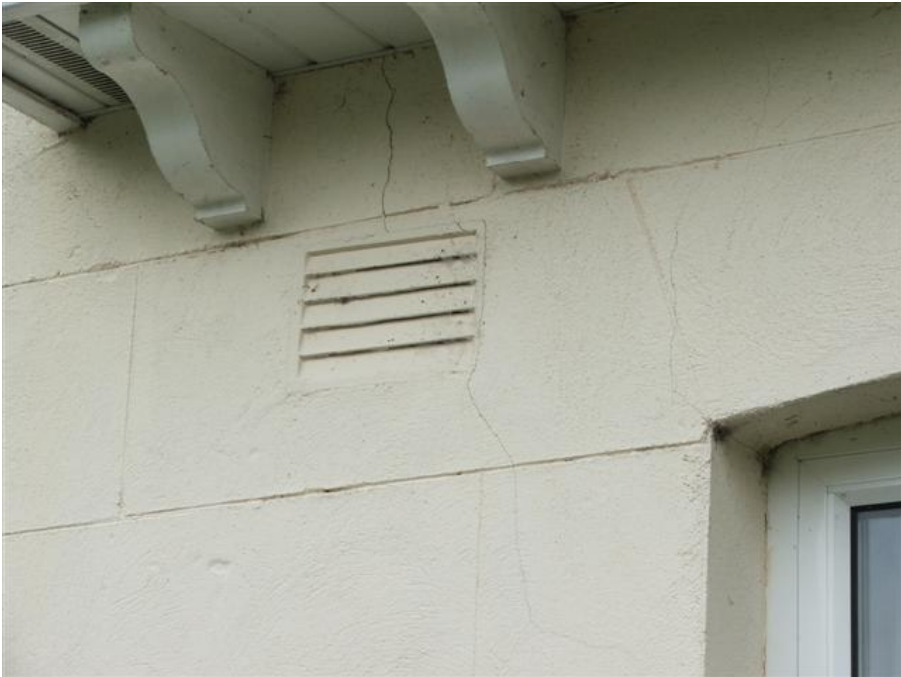
Details are correct and complete at openings, at external corners, abutting masonry, at terminations, e.g. top. There were a number of minor expansion cracks evident in the external walls (see attached photos) however they are not structurally significant. There is also a poorly finished extract vent from the cooker extract fan.

Photo 4: Showing expansion crack to wall.

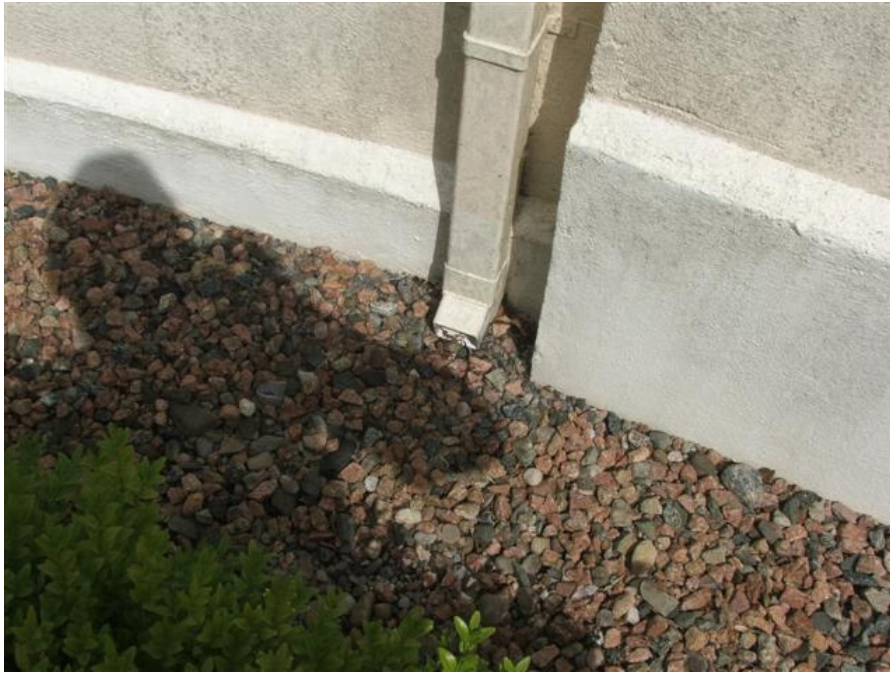
Gulley traps are not situated to meet downpipes, see comments relating to the gutters above. Gulley traps are NOT sealed to concrete path and water can escape down both the back and sides of gulley traps. There is a need to provide a concrete path around the property and have all the gulley traps and AJ's sealed to the path. This work should be carried out as part of the overall improvement of the drainage system.

Photo 5: Showing no surface water gully trap.

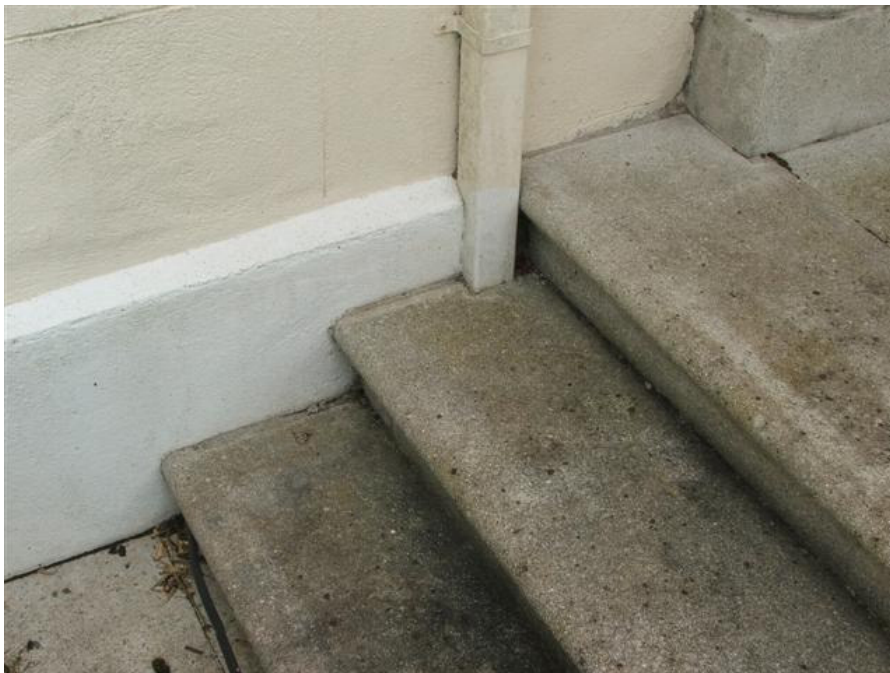
The gutters are in need of cleaning both internally and externally. There is a major deficiency in the manner of the rainwater discharge from the property. There appears to be no surface water drainage in place at all and the rainwater is simply being discharged directly to the ground beside the property. This can cause dampness within the house and more importantly can result in the washing of all fine material from the ground adjacent to the foundations causing potential undermining of the foundations. This issue must be addressed. See attached photos.

Photo 6: Showing down pipe with no identifiable means of discharging the surface water.

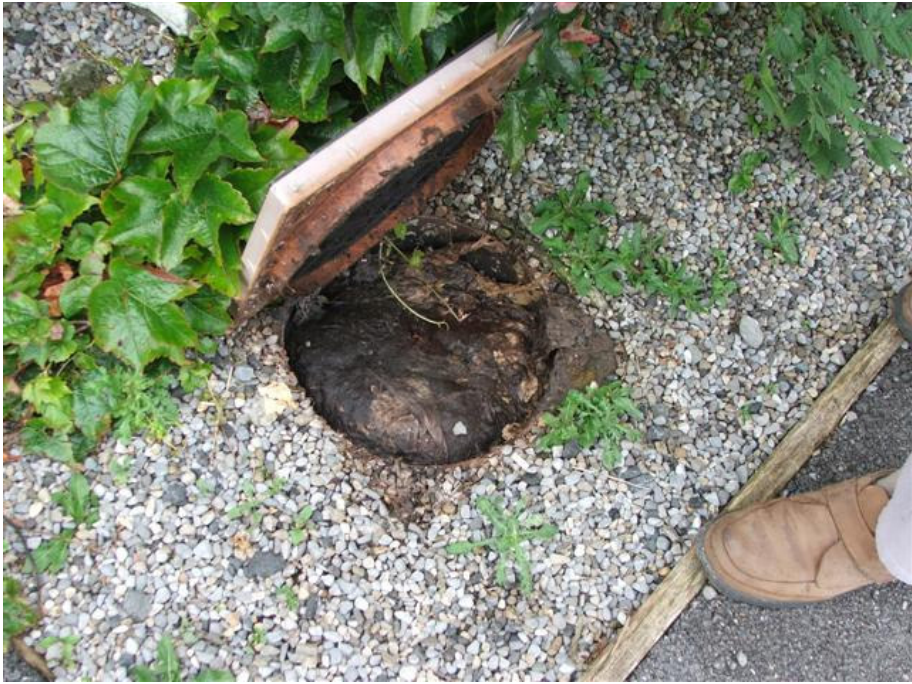
Access to the waste pipes is limited. The raised deck patio is blocking access to the discharge from the kitchen and all of the remaining waste water seems to be discharging by means of either back inlet gulley traps or through sealed sewer systems. Furthermore there is a major problem with the sewer pipes and general arrangement of the AJ covers. There is blockage in the sewer pipes at the side of the property and the AJ covers are not properly sealed the pipe system. Again this needs to be urgently addressed.

Photo 7: Showing the blocked foul sewer.

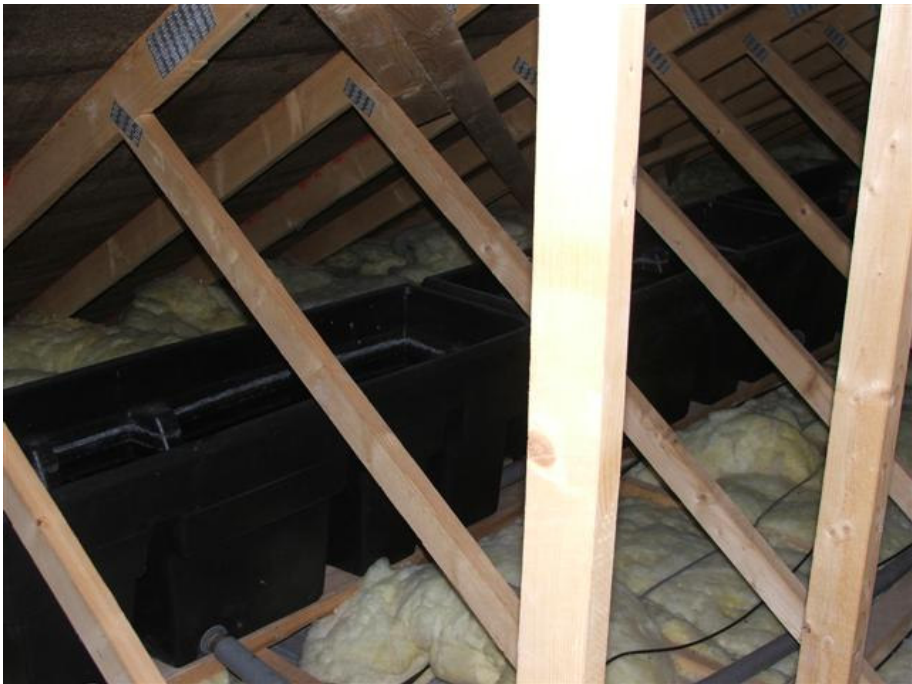
Insulation to tank is NOT complete, this should be addressed.

Photo 8: Showing the water tank uninsulated.

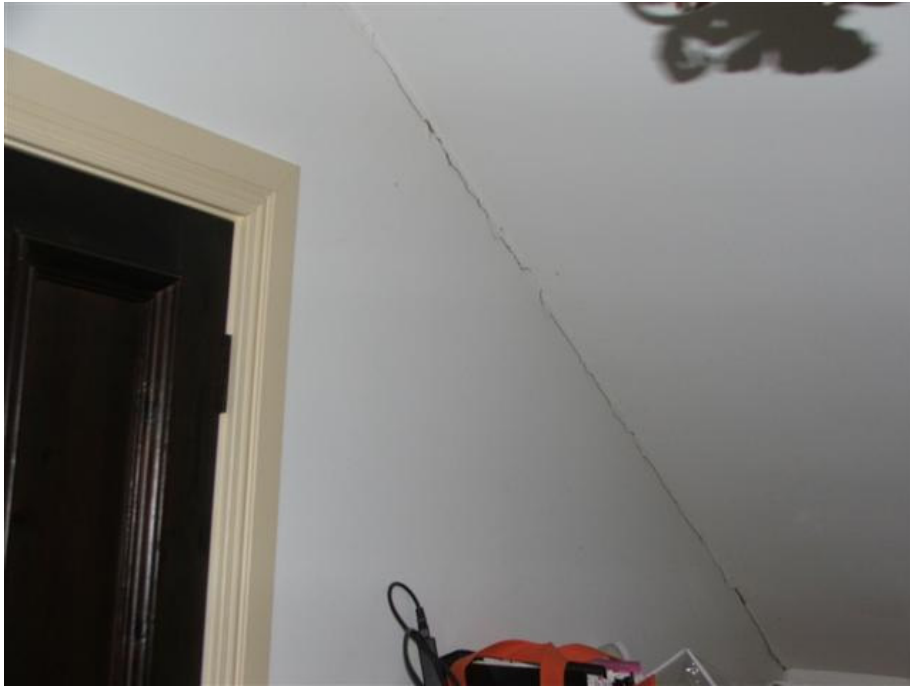
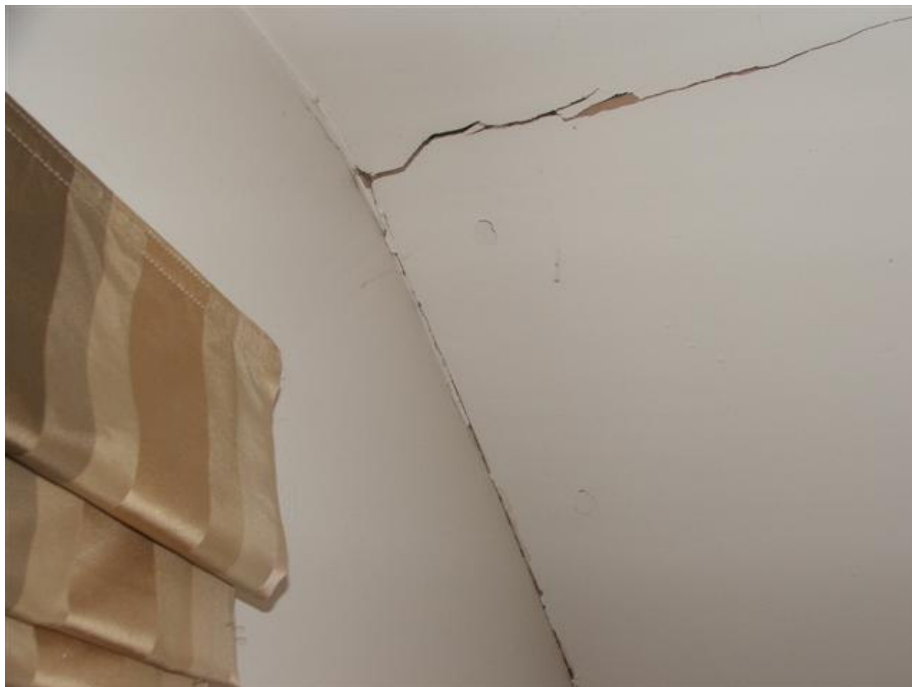
The attic over the dressing room has not been braced or strapped to the gable wall. In this case it has caused some limited structural damage to the roof. There is evidence of movement of the roof possibly in high winds and this has resulted in cracking to the interior ceiling. There is urgent need to brace this section of the attic and strap the last two rafters to the gable wall. There is limited access to the attic, however the current access, by means of the crawl way on both sides of the dressing room, should provide sufficient access to carry out this work.

There was a crack between the ceiling and the wall in the walk in wardrobe this appears to be a structural crack caused by the absence of bracing to this section of the roof. There is a possibility that the construction of the attic walk in wardrobe was an afterthought and the bracing was omitted accidentally.

Photo 9: Showing the crack at the ceiling of the walk in wardrobe.

Photo 10: Showing the crack at the ceiling of the walk in wardrobe.
