CONOR FUREY & ASSOCIATES LTD
Consulting Engineers and Project Managers

ENGINEER'S SURVEY REPORT

2nd Hand House Survey

Inspected on: - 7th July 2013

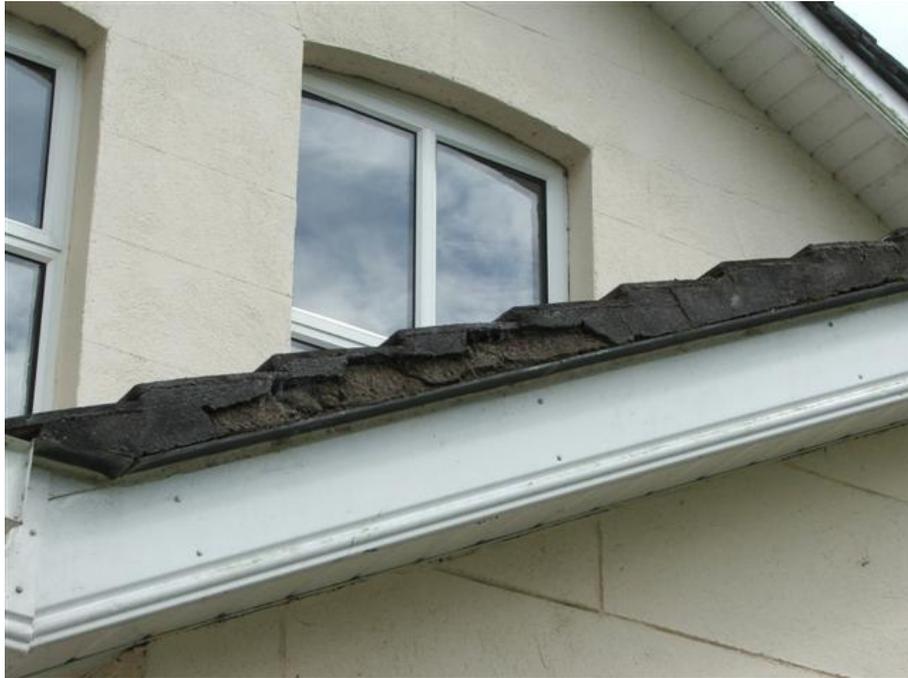
Roof tiles are complete. Bedding mortar at the verges of the porch are in need of repair. Proprietary ridge systems are complete. There are no cracked or slipped tiles. The roof covering is free from mortar. The line is even and the gauge is correct.

Photo 1: Showing bedding mortar missing from eaves of porch.

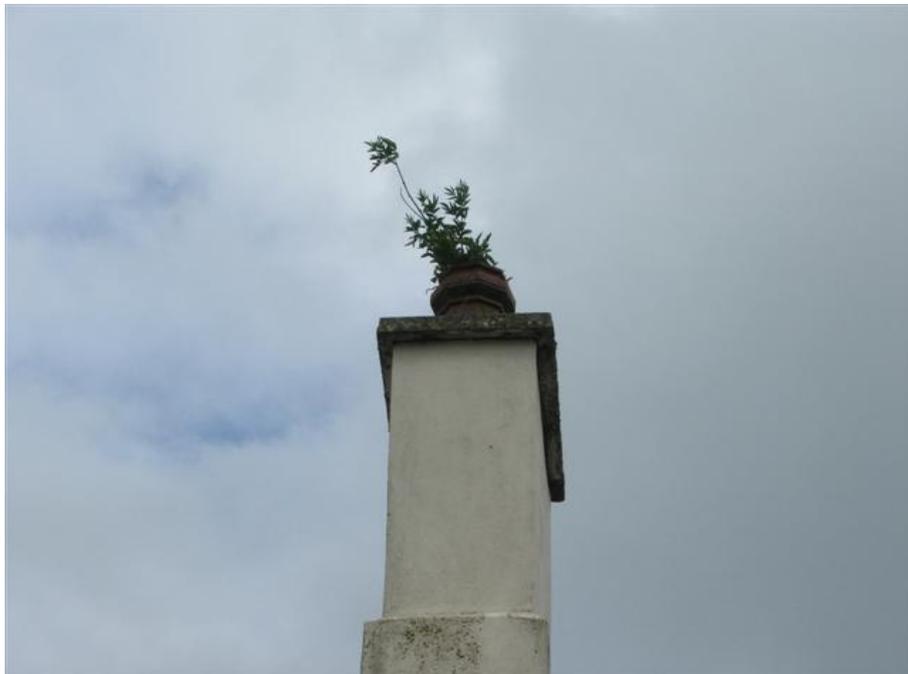
Flashings are correctly installed, wedged and pointed up. There is evidence of vegetation growing within the chimney stack this must be addressed, see attached photo.

Photo 2: Showing vegetation in chimney.

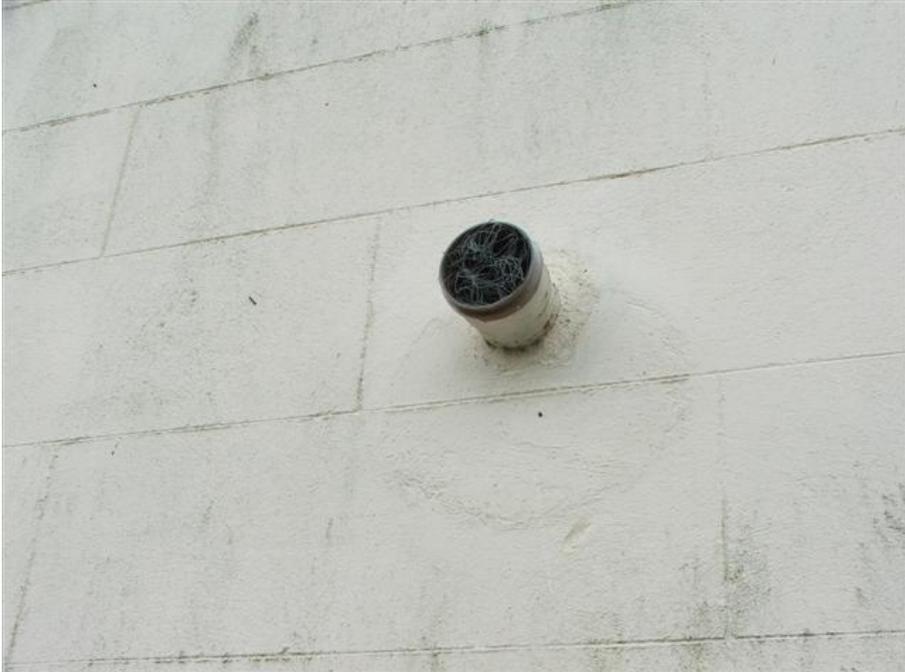
Details are correct and complete at openings, at external corners, abutting masonry, at terminations, e.g. top. There were a number of minor expansion cracks evident in the external walls (see attached photos) however they are not structurally significant. There is also a poorly finished extract vent from the cooker extract fan.

Photo 3: Showing poor finish to extract vent from kitchen.

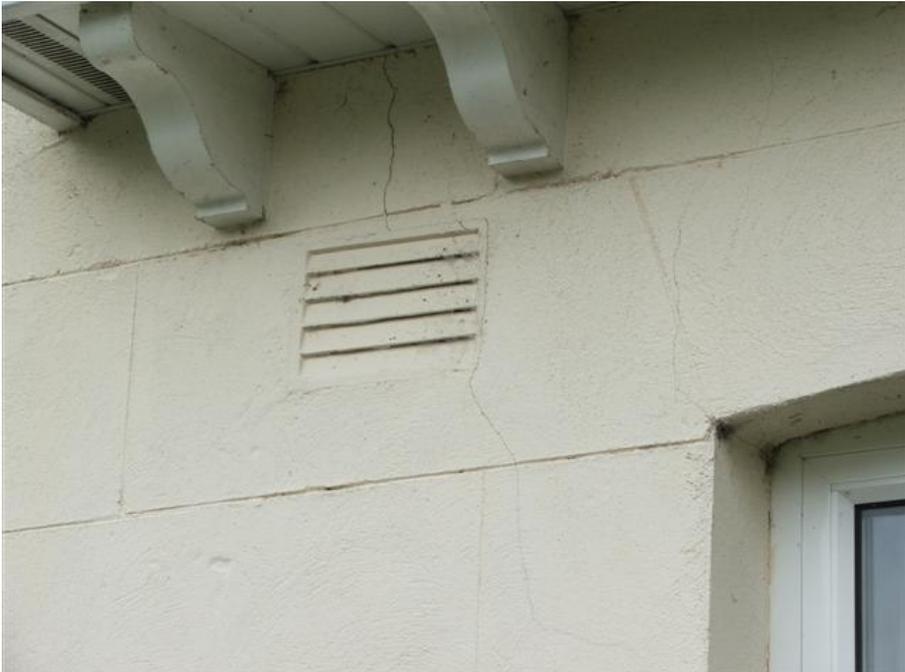
Photo 4: Showing expansion crack to wall.

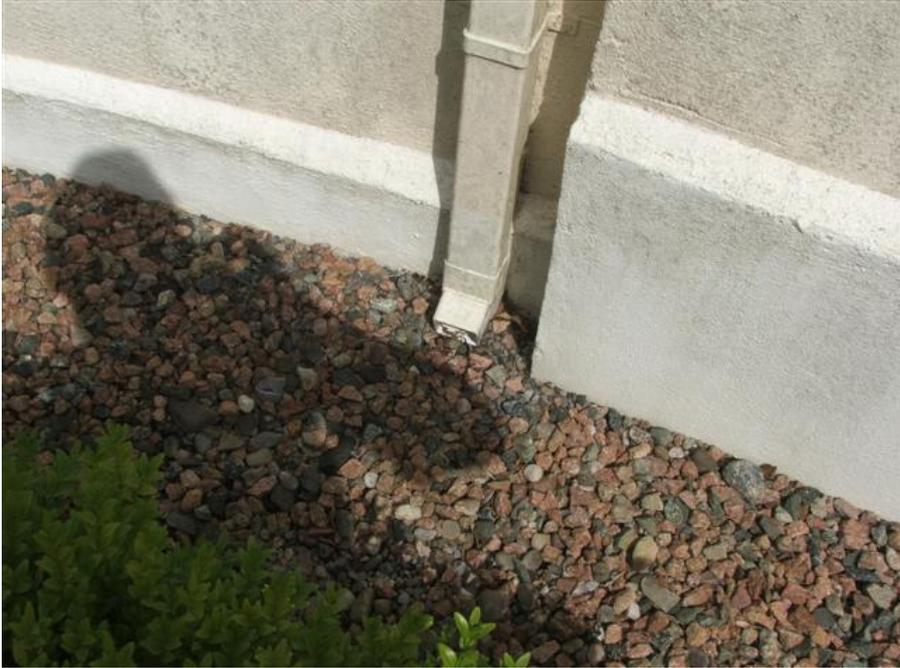
Gulley traps are not situated to meet downpipes, see comments relating to the gutters above. Gulley traps are NOT sealed to concrete path and water can escape down both the back and sides of gulley traps. There is a need to provide a concrete path around the property and have all the gulley traps and AJ's sealed to the path. This work should be carried out as part of the overall improvement of the drainage system.

Photo 5: Showing no surface water gully trap.

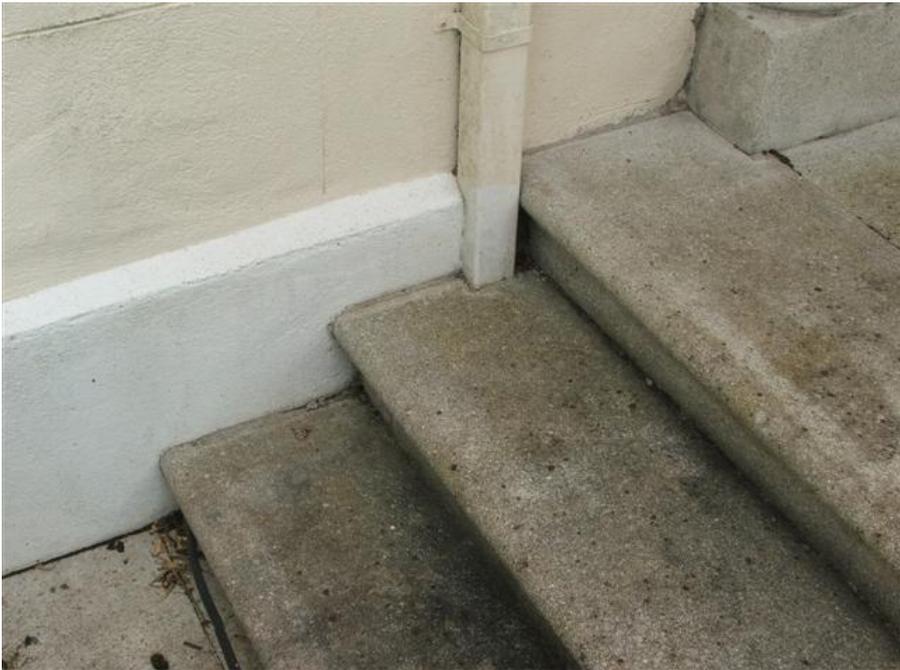
The gutters are in need of cleaning both internally and externally. There is a major deficiency in the manner of the rainwater discharge from the property. There appears to be no surface water drainage in place at all and the rainwater is simply being discharged directly to the ground beside the property. This can cause dampness within the house and more importantly can result in the washing of all fine material from the ground adjacent to the foundations causing potential undermining of the foundations. This issue must be addressed. See attached photos.

Photo 6: Showing down pipe with no identifiable means of discharging the surface water.

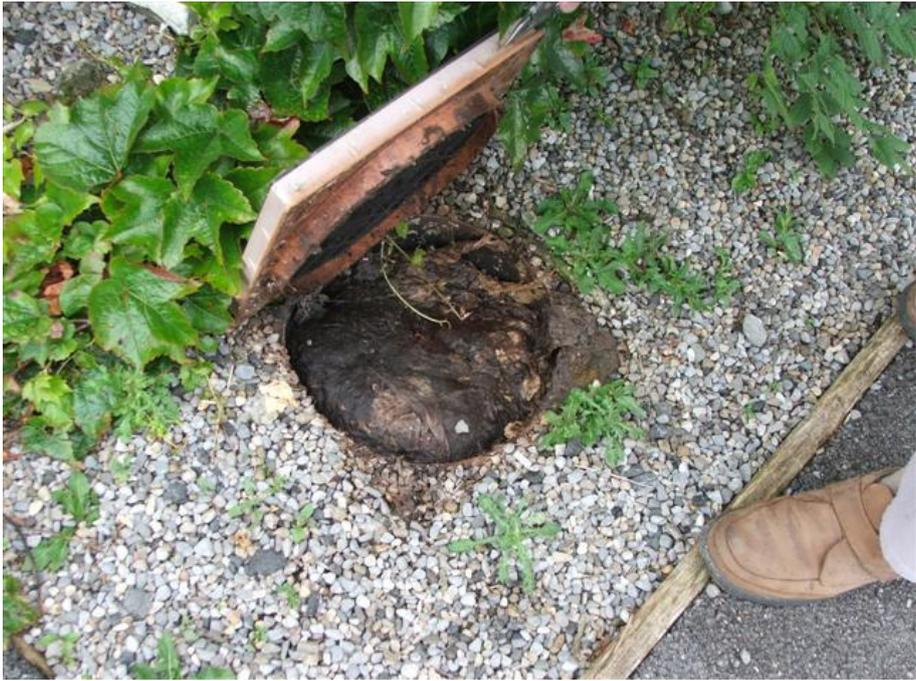
Access to the waste pipes is limited. The raised deck patio is blocking access to the discharge from the kitchen and all of the remaining waste water seems to be discharging by means of either back inlet gulley traps or through sealed sewer systems. Furthermore there is a major problem with the sewer pipes and general arrangement of the AJ covers. There is blockage in the sewer pipes at the side of the property and the AJ covers are not properly sealed the pipe system. Again this needs to be urgently addressed.

Photo 7: Showing the blocked foul sewer.

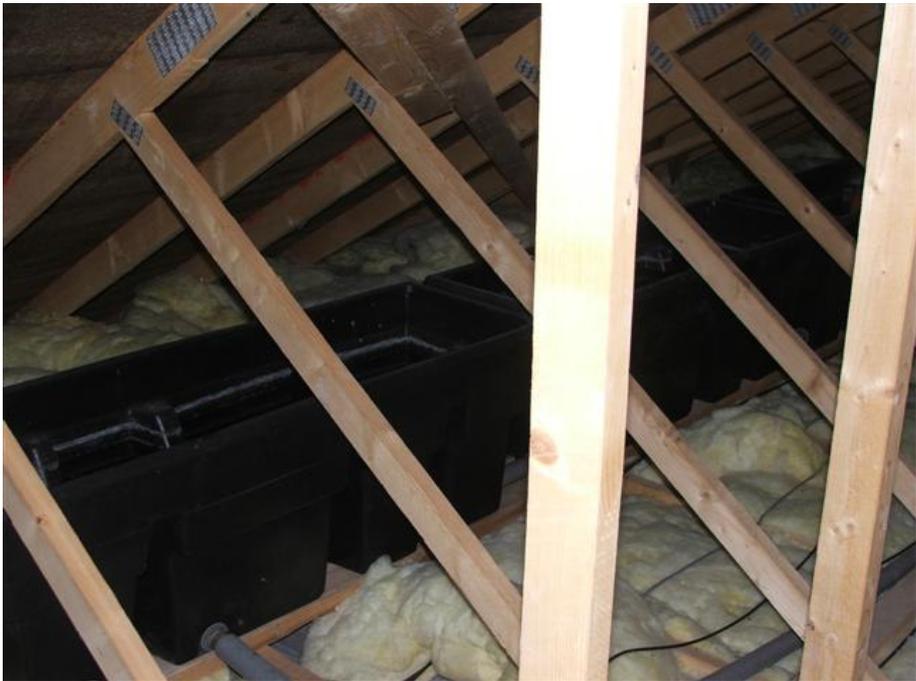
Insulation to tank is NOT complete, this should be addressed.

Photo 8: Showing the water tank uninsulated.

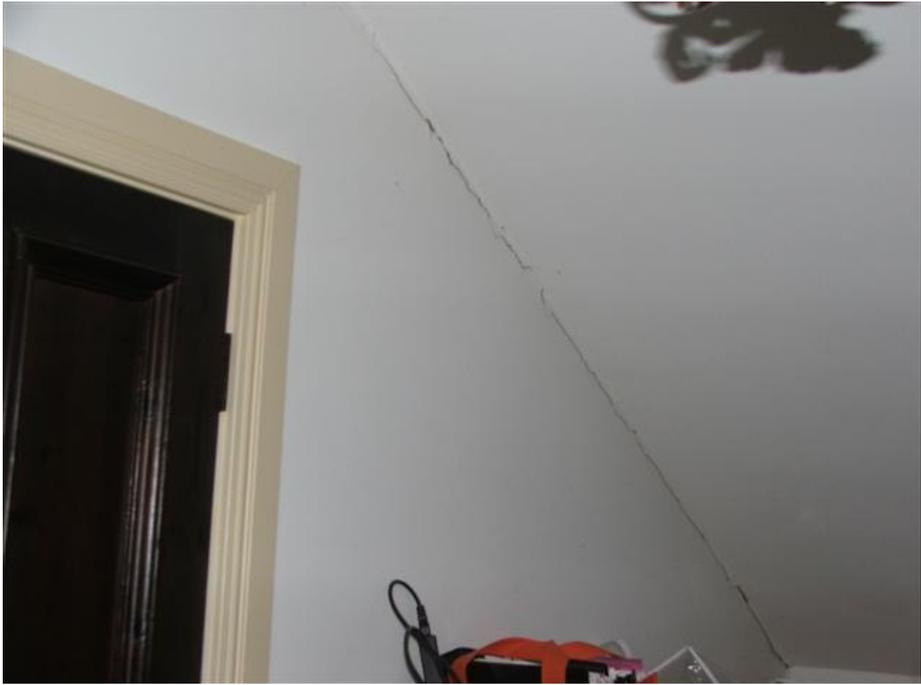
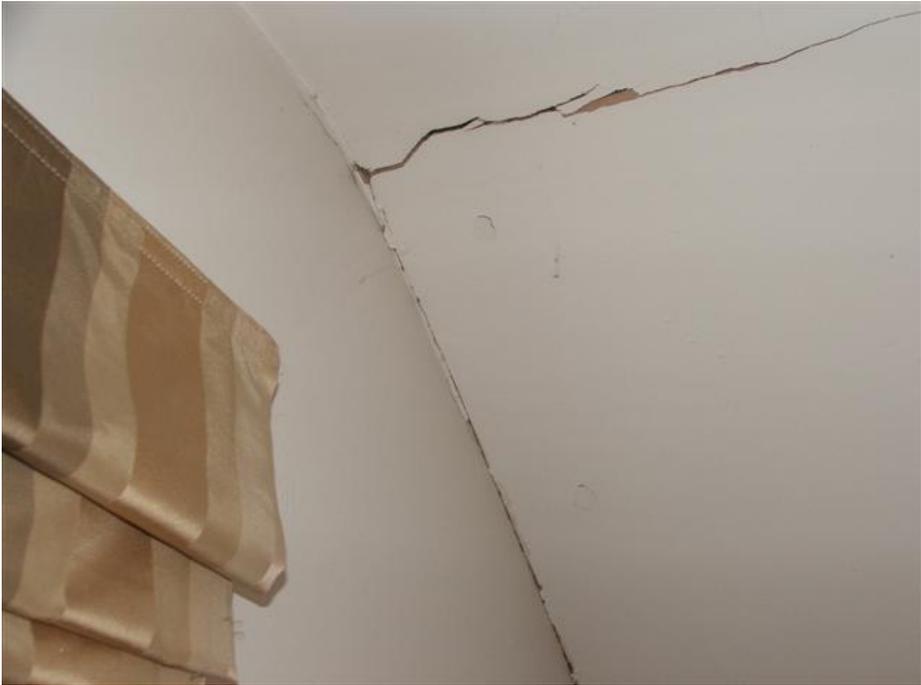
The attic over the dressing room has not been braced or strapped to the gable wall. In this case it has caused some limited structural damage to the roof. There is evidence of movement of the roof possibly in high winds and this has resulted in cracking to the interior ceiling. There is urgent need to brace this section of the attic and strap the last two rafters to the gable wall. There is limited access to the attic, however the current access, by means of the crawl way on both sides of the dressing room, should provide sufficient access to carry out this work.

There was a crack between the ceiling and the wall in the walk in wardrobe this appears to be a structural crack caused by the absence of bracing to this section of the roof. There is a possibility that the construction of the attic walk in wardrobe was an afterthought and the bracing was omitted accidentally.

Photo 9: Showing the crack at the ceiling of the walk in wardrobe.

Photo 10: Showing the crack at the ceiling of the walk in wardrobe.
