## ENGINEER'S SURVEY REPORT

### 2nd Hand House Survey

<b>Property:</b>	<b>Countryside, Rural Ireland, Ireland.</b>
<b>Client:</b>	<b>John Joe O'Neill</b>
<b>Inspected on:</b>	<b>1<sup>st</sup> July 2020</b>
<b>Inspected by:</b>	<b>Peter Conran</b>

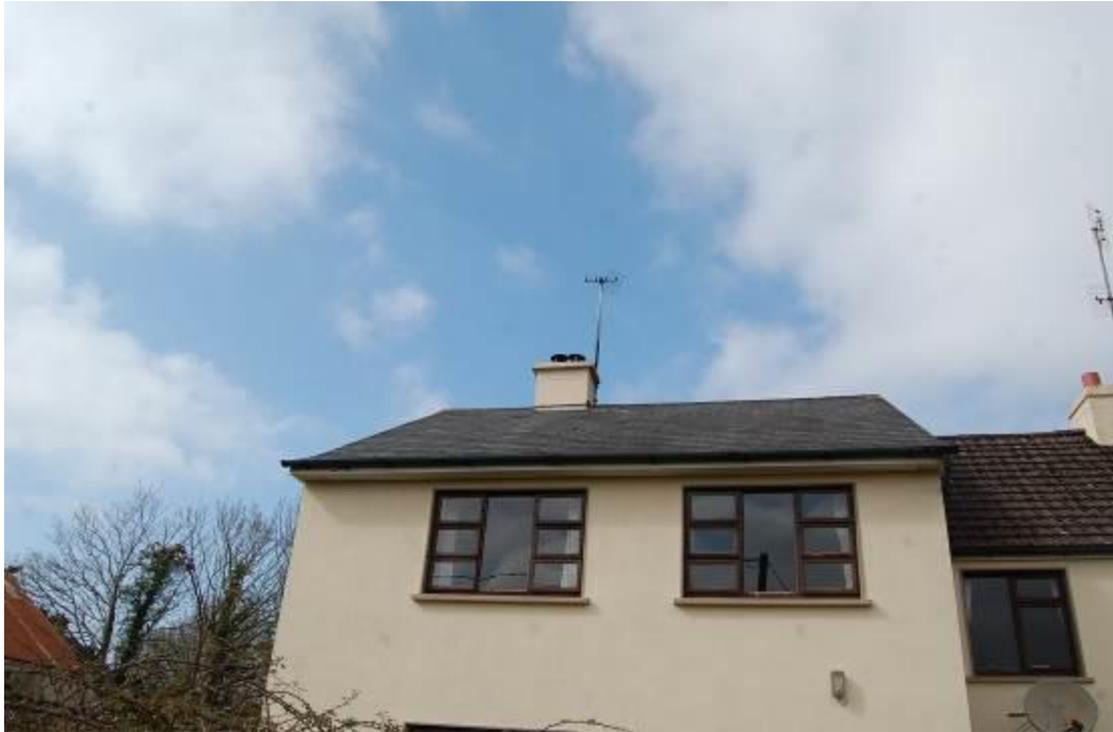
The roof is covered with manufactured slates. The slates are complete with no broken or missing slates evident. The ridge line is even and the gauge is correct.

Photo 1 General View Front Roof of Extension

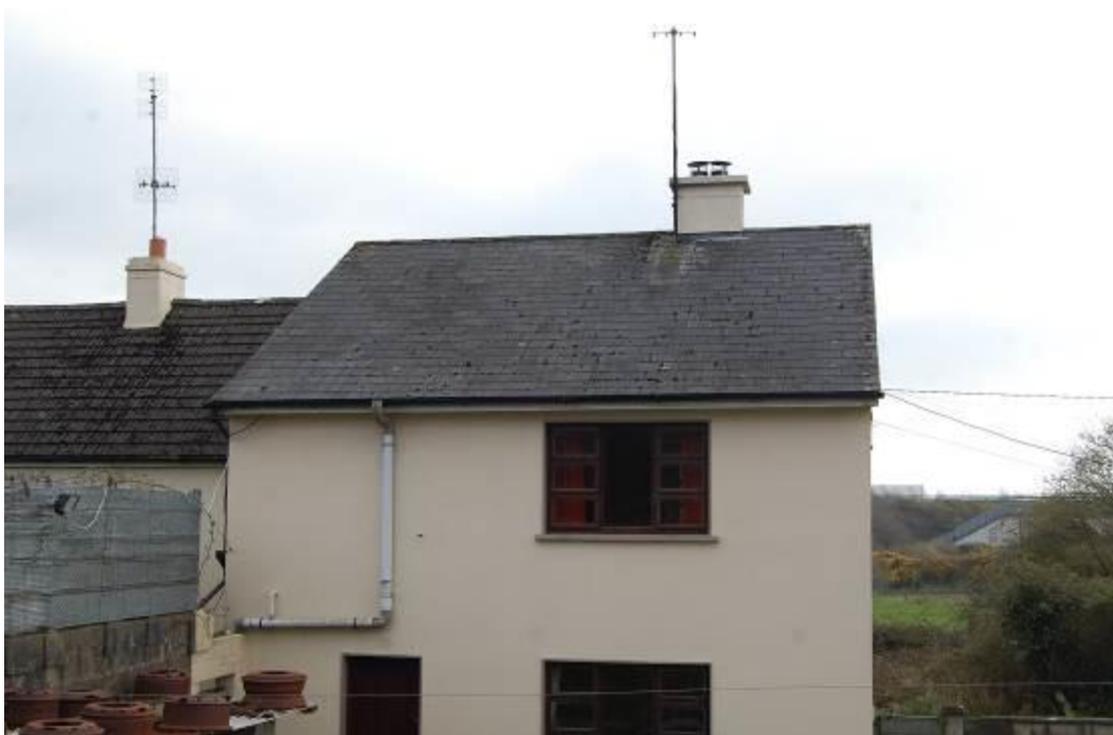
Photo 2 General View Rear Roof Extension

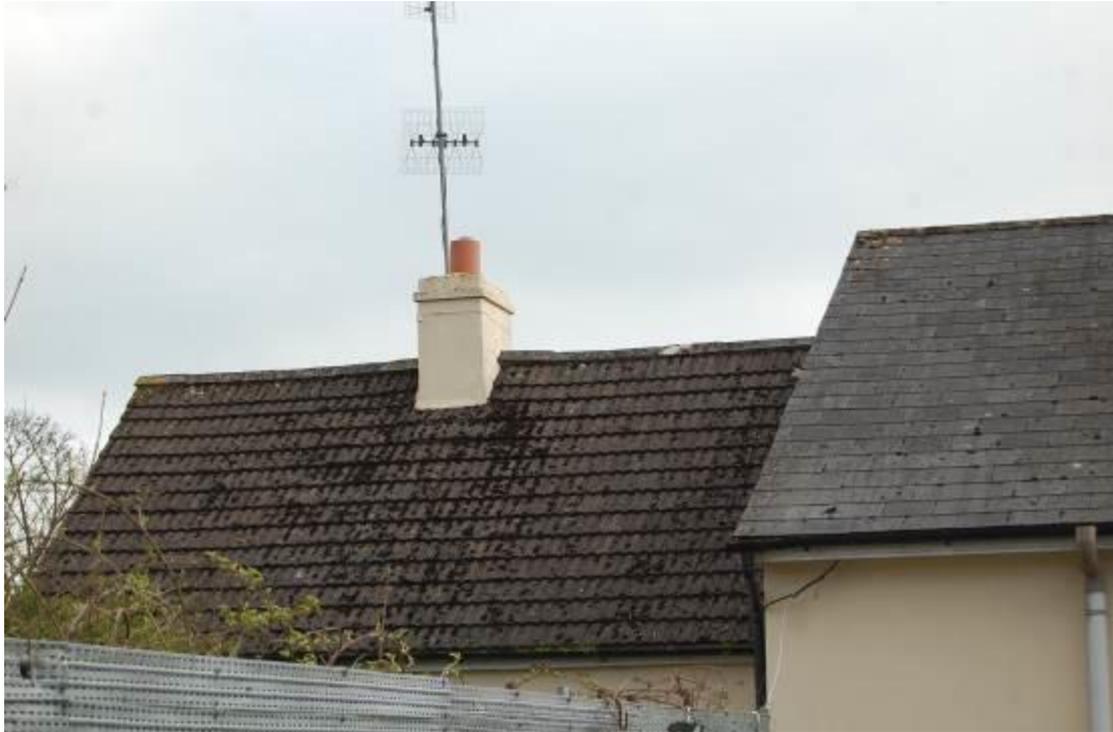
The roof is covered with a red concrete roof tile. There is a matching ridge tile bedded in with mortar. The roof abuts against the gable wall of the extension. The ridge line is uneven in particular on the left hand side (viewed from the front) between the chimney and the gable wall of the extension. The ridge tiles are intact and there is no evidence of any leaks. Internally in the attic space there is some evidence of repair works having been carried out around the chimney and this accounts for the uneven ridge. Currently the ridge is intact, there is no evidence of any leaks but externally it is visually slightly incorrect. At the open gable end of the roof the tiles overhang the gable slightly which is good practice but there is a difference between the front slope and the rear slope. On the front there is a 75mm (approx) overhang while on the rear there is little or no overhang. The vertical line of the old gable wall is probably a bit off. This is not a structural issue but again is slightly visually off.

We note below that there is no sarking felt on this older roof. This was a common form of construction when this roof was constructed and it is perfectly adequate as long as there are no broken or missing tiles. On this roof the tiles on the front elevation are good and internally no leaks are evident. However, on the rear elevation there are two locations where tiles are damaged. Viewed from the rear there is a broken tile on the top right just below the ridge line between the chimney and the gable. This has been repaired with a piece of flat metal sheet. Internally there is no evidence of a leak in this area so the repair is doing the job, nevertheless, it is a temporary repair and a proper repair with a new tile is required. A second area is on the lower left hand side of the rear elevation (viewed from the rear).

Approximately 6 rows up from the gutter and 8 tiles in from the open gable there is a cracked tile. The problem, with not having any felt under the tile, is that when a tile cracks, as in this case, there will be a leak internally. This is evident on the sloped ceiling of the room immediately below this portion of the roof. There is a second tile in the same area that appears to have a damaged surface that may also be leaking.

Photo 3 Rear old Roof Note poor ridge line. Broken tiles need to be replaced

So work is required to the tiles on the rear elevation. An experienced roofer will need to be engaged, because on this old roof, care is needed to ensure that additional tiles are not damaged while trying to carry out repairs to the few that need attention now. This is all the more important when you have a situation, as in this case, where there is no felt under the tile.

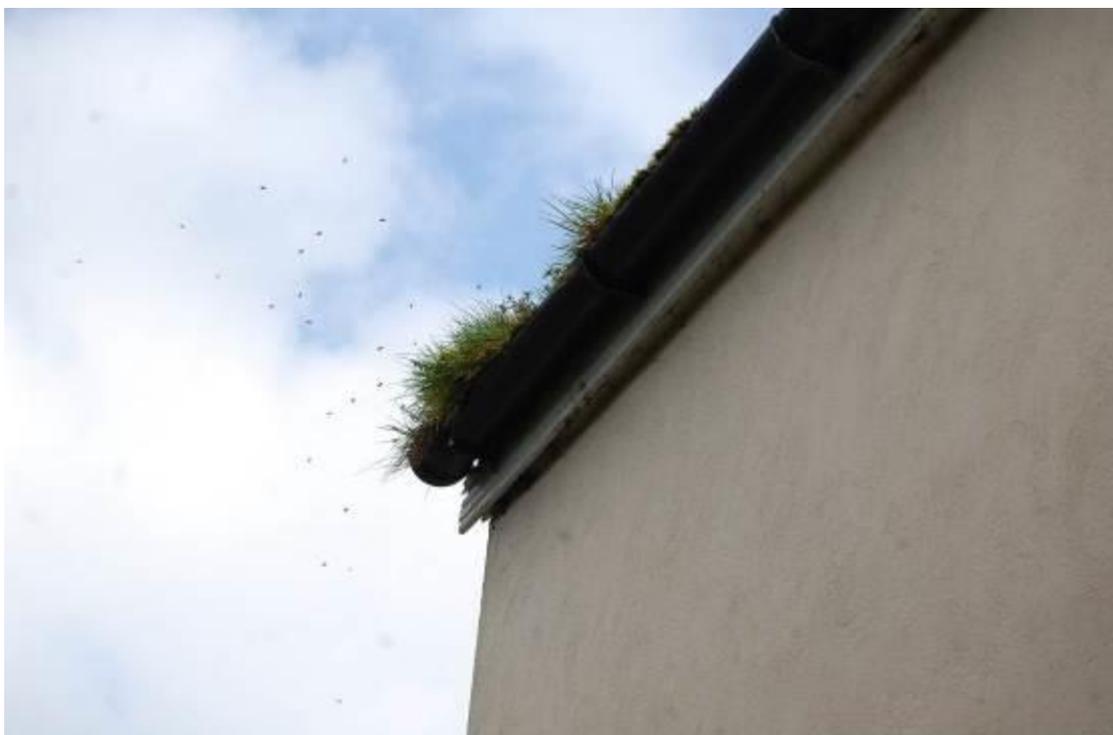
There is a timber fascia and soffit to the front and rear elevations of both roofs. The gables are finished with a poured concrete barge. The fascia and soffit on the extension roof are in good condition but will require painting from time to time. On the older roof there is also timber fascia and soffit which appears to be in reasonably good condition. Similar to the gable/roof joint mentioned above the line of the soffit varies along the length of the wall and this indicates that the vertical line of the wall is slightly off. Similar to the gable, this is not structurally significant, but is unsightly.

There are half round PVC gutters on both roofs. Generally in good condition but on the rear of the old roof there is significant grass growth in the gutter and they badly need to be cleared.

We also noted there is a wasp/bee nest at the soffit/gable corner of the old roof where there is a lot of grass in the gutter.

Photo 4 Wasp Nest, Grass in Gutter and varying Width of Soffit Old Roof

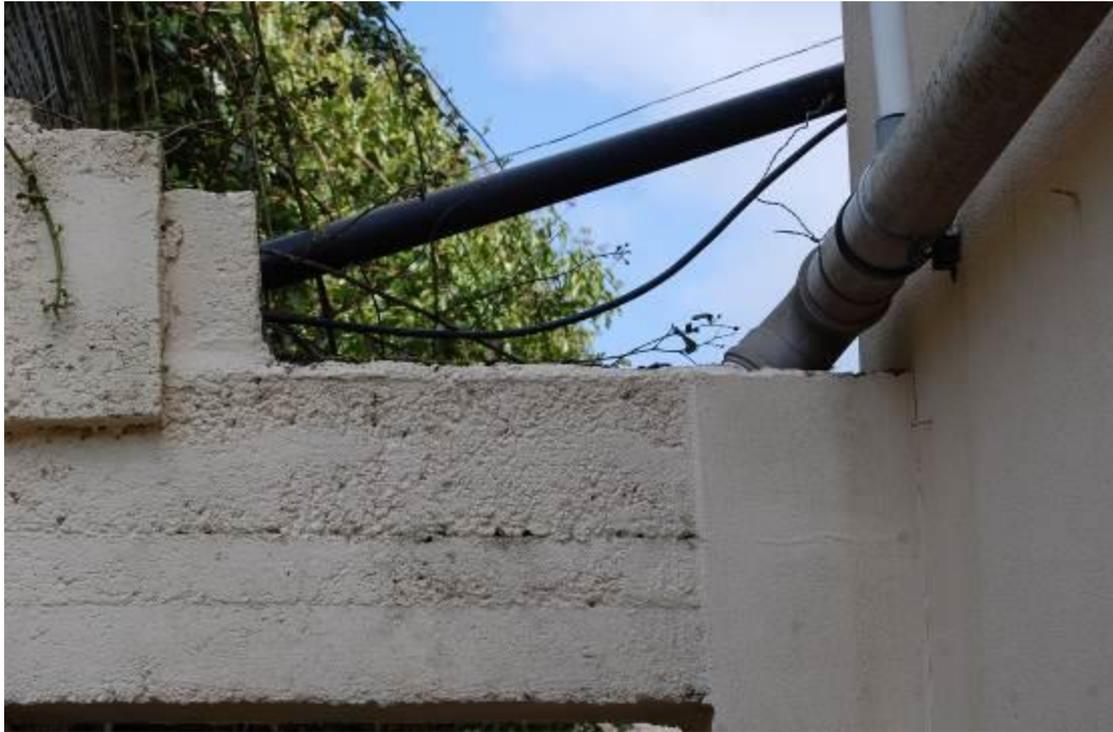
There is a 100mm PVC waste pipe from the first floor bathroom (see later comments under drainage). This is the soil vent pipe and extends up to the gutter as well as down to the drain. The pipe terminates at the gutter which is a bit low for a soil vent pipe. It is recommended that the pipe is extended at least 500mm above the gutter to ensure that foul smells are not drawn back in through first floor windows.

When the extension was built in the eighties a new septic tank was installed at the rear of the house. This was located at a high level and possibly in ground that was dugout for the foundations of the new extension. The height of this septic tank means that it cannot service the existing kitchen or anything on the ground floor level. The waste pipe from the first floor level comes out the rear

Photo 5 Soil Pipe cased into wall at high level going to high Level Septic Tank

We would recommend that a view is taken that the two existing tanks will be made redundant and a completely new tank and percolation area is installed in line with current regulations. The one tank should be located so that it can serve the whole house. Therefore the tank put in installed in the eighties will not suffice. The older tank from the thirties would just need replacement anyway.

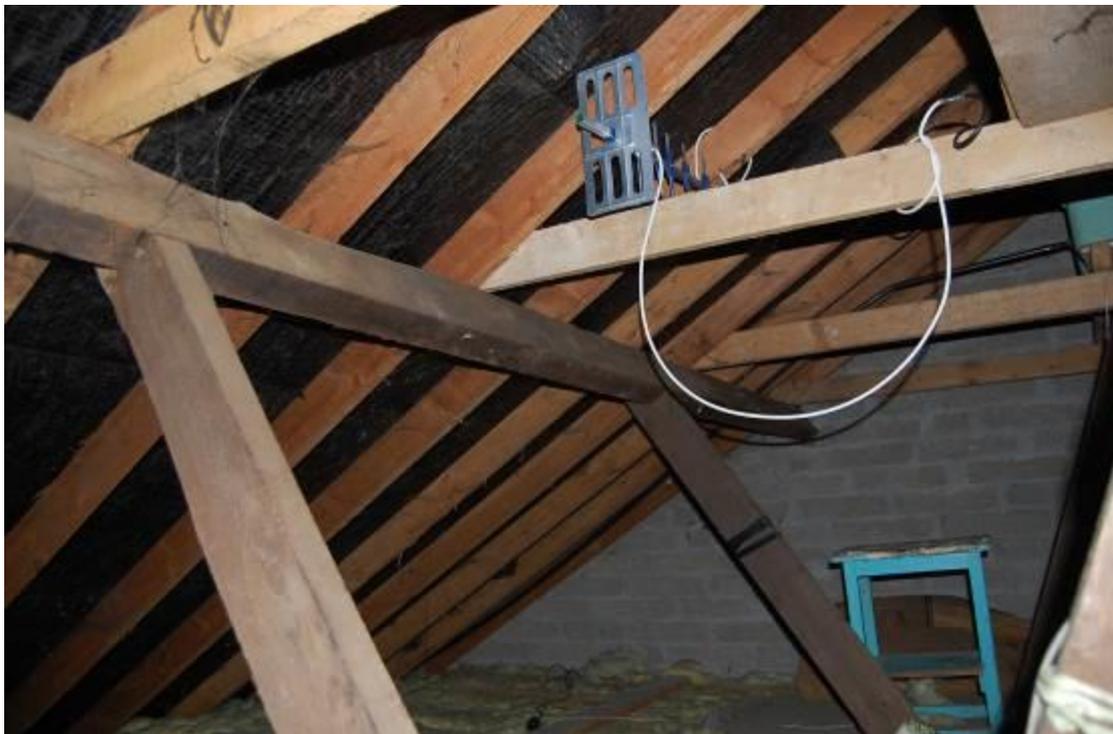
Cut timber roof with timber rafters at 400 mm spacing supported by timber purlins at half way point between the eaves and the ridge. The roof is in good structural condition.

Photo 6 Typical View of Roof Timbers in Extension

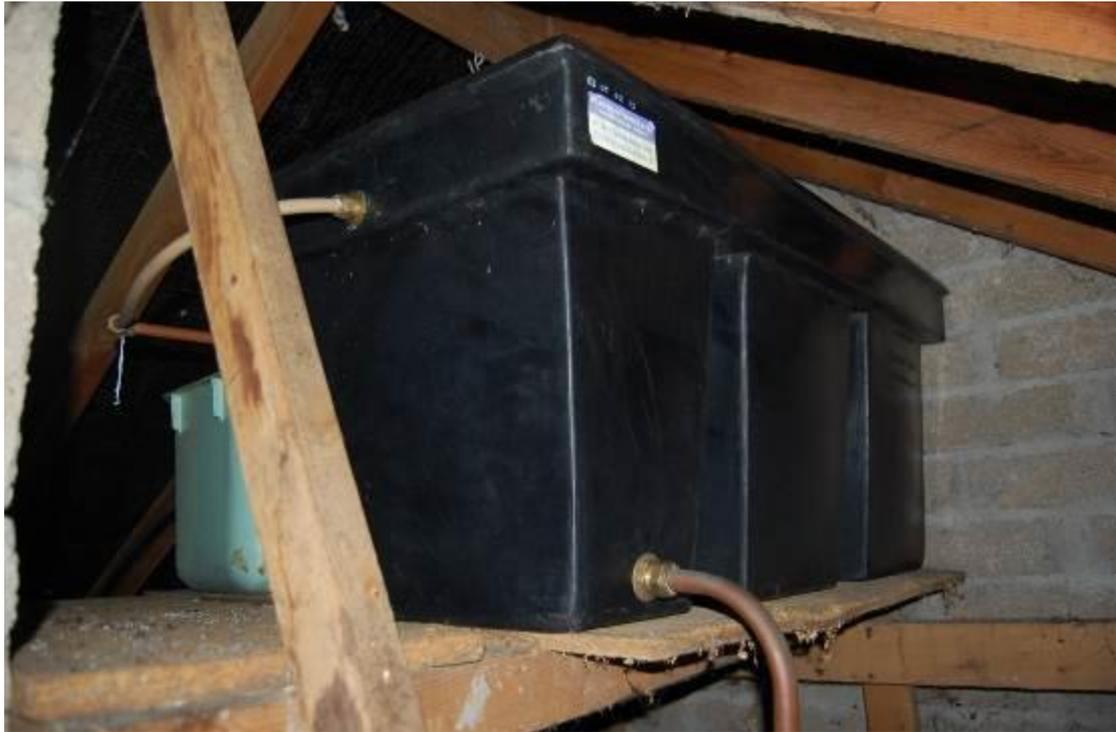
There is a PVC water storage tank and a header tank for the heating system. Both tanks are in good condition. They are located on a platform approximately 900mm above the ceiling level in the extension attic space. The platform for the tanks is level and as originally constructed. However, the timbers used and the general construction of the platform is a bit light and we recommend that a more substantial platform is constructed to support the tank. The tanks are not insulated and given the high level in the attic, insulation is strongly recommended. This should include all of the pipes going to and coming from the tanks.

Photo 7 Water Tanks in Attic are not Insulated and Supported on a Weak Platform

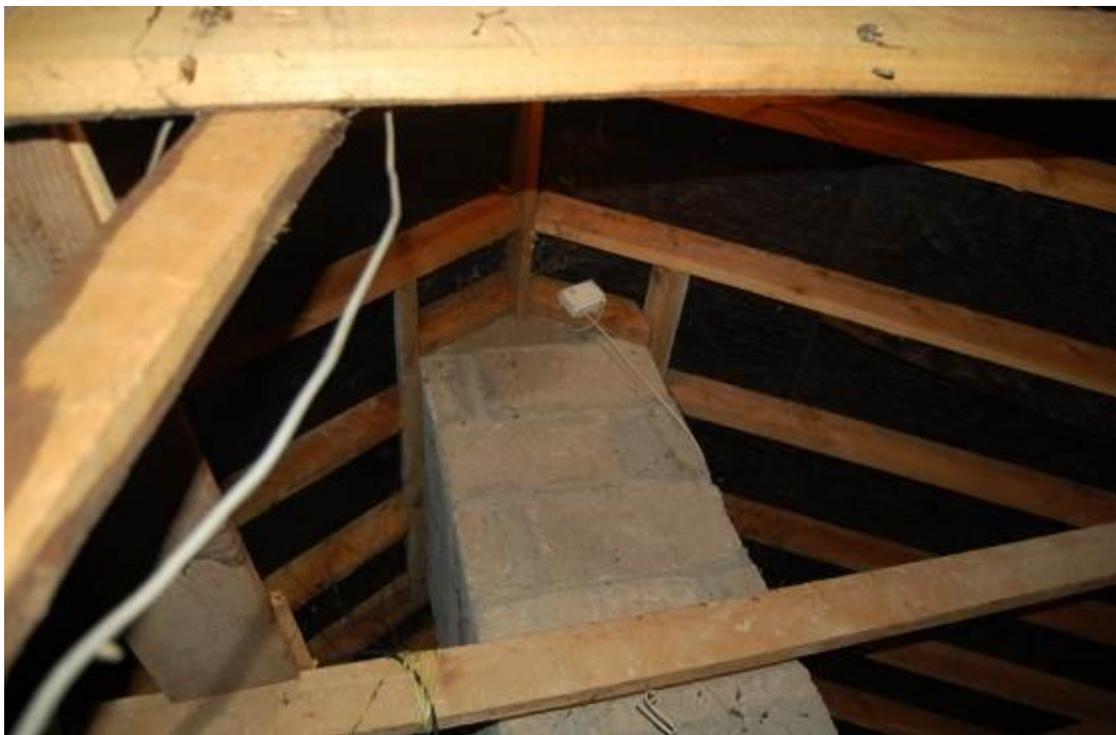
The chimney on the new roof is block built with a napp render finish. The chimney is in good structural condition and the lead flashing around the chimney is in good condition. Internally there is no evidence of any leaks around the block/roof joints.

Photo 8 Good Dry Blocks of Chimney in Extension

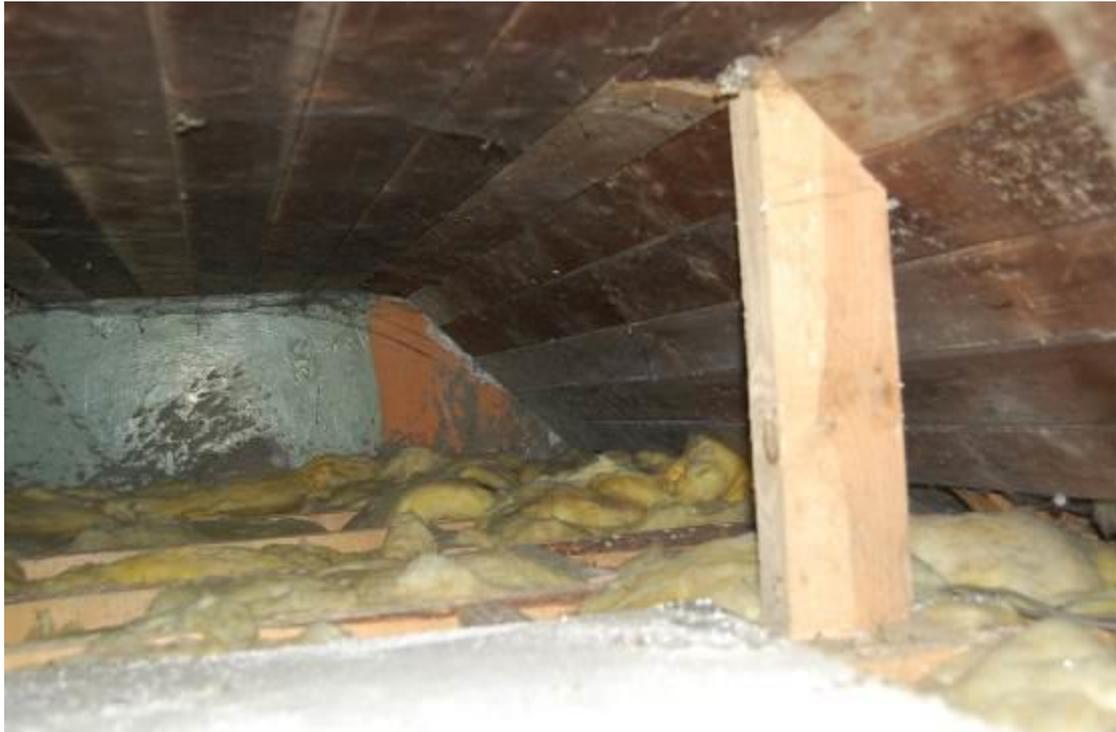
Over half of this roof the ceiling has been dropped below the original sloped ceiling that followed the slope of the rafter.

Photo 9 Dropped Ceiling in Original Part of House

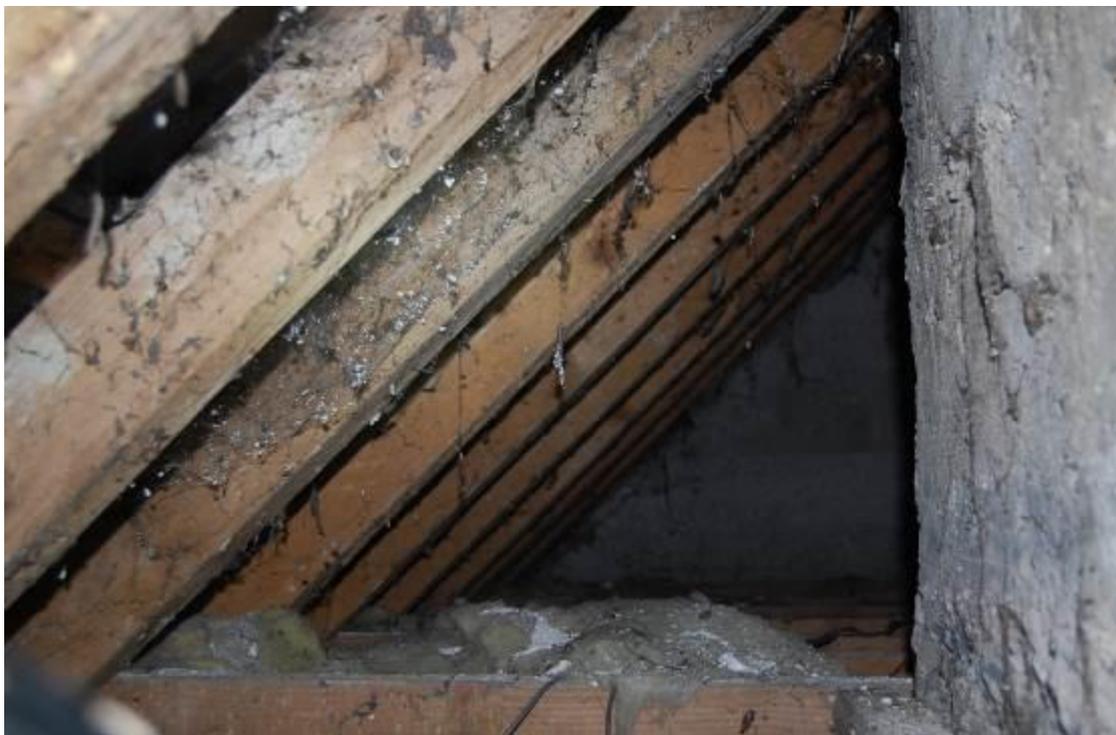
This is also a cut timber roof but has much shorter spans between the eaves and the ridge line. The access to this space is much tighter than the extension roof and our view was only from the relatively small access hatch. Generally the timbers are in good condition and no evidence of timber decay was noted. Note that we did not have a view of the rafter ends or the wall plate and the previous statement must take this into account. There has been some repairs carried out to rafters near the chimney and this was referenced earlier in regard to the line of the ridge. The repair to the rafter is good and no ongoing problems were noted.

Photo 10 Roof Timbers in Original Roof

When the broken tile is being repaired it may be found that repairs are required to some rafters in that area. We were unable to view the area directly internally. However, given that there is no sag in the roof it is more likely that the timbers are structurally fine and may just need to be dried out.

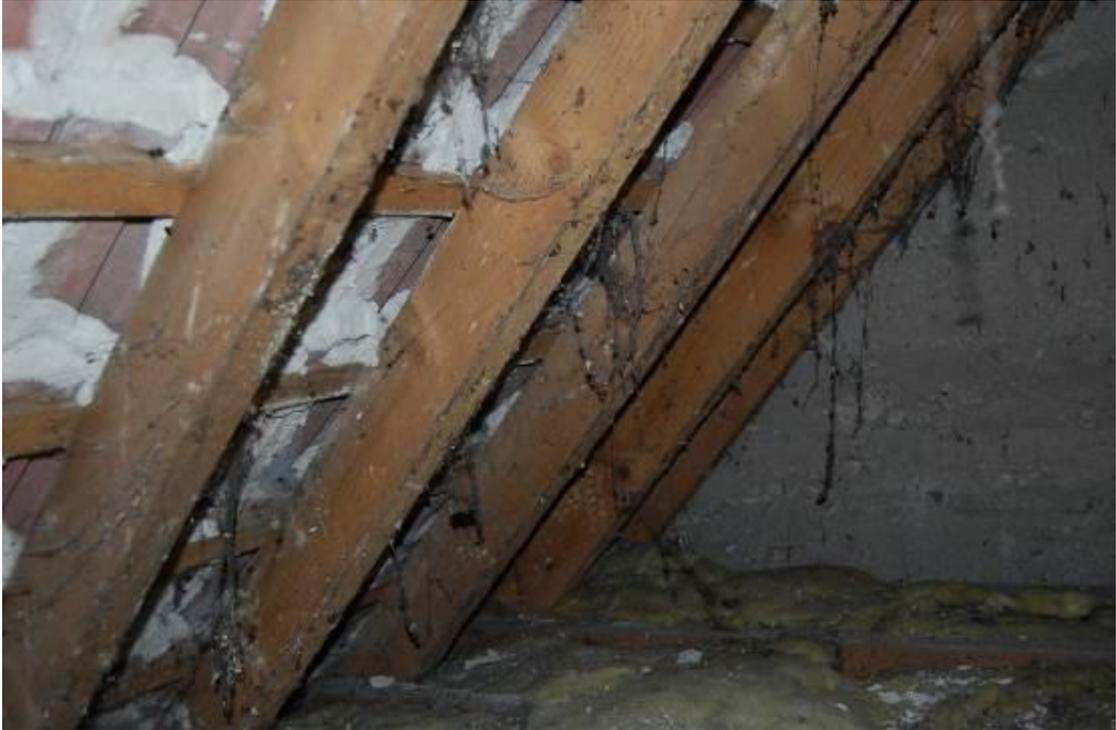
As noted earlier in the report there is no felt on this section of the roof. A lime parging is fixed to the underside of the tile which helps to seal gaps and hold the tile in place. This is in good condition.

As referenced above, the problem with not having felt is that there is no second line of defence in the event of a problem occurring with the roof tile.

Photo 11 Lime Parging rather than Felt to Original Roof

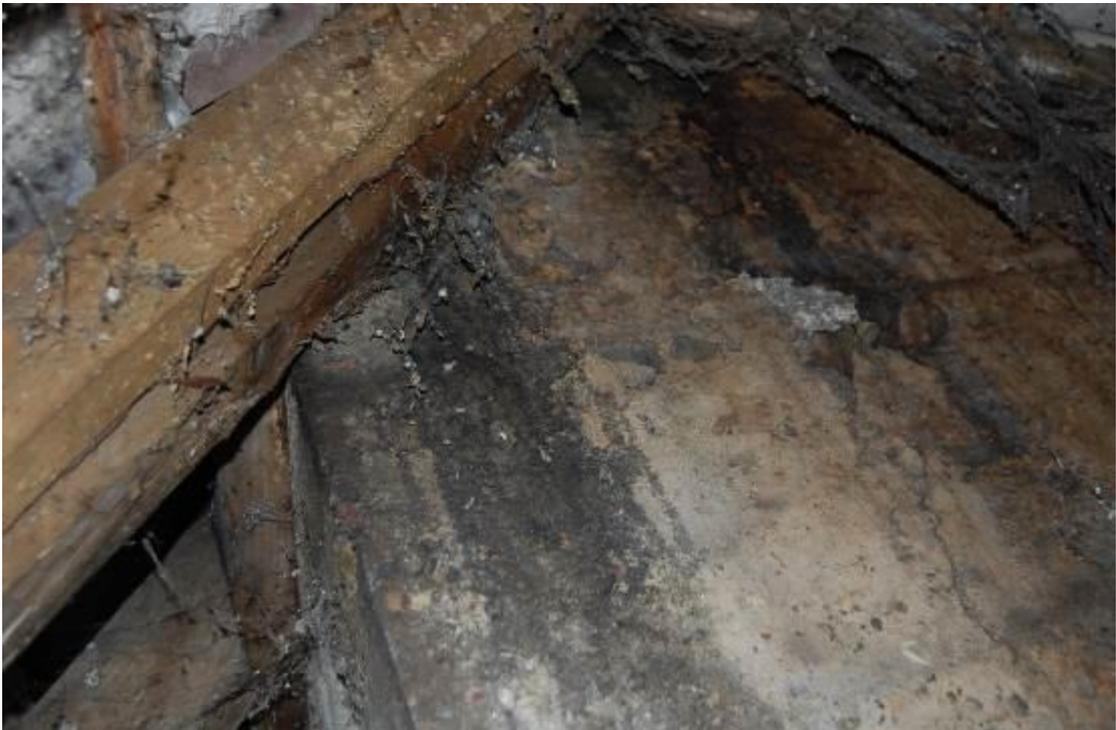
On the older chimney there is a flue that serves the open fire in the ground floor small sitting room. Internally in the attic space there is some staining on the blockwork that indicates there may be some small gaps in the flue liner joints. If so it is minor but nevertheless if the fireplace is going to be in regular use we would recommend that the flue is inspected internally with a camera and it may require a flue liner. Alternatively one could make the assumption that a flue liner is definitely required and have it done. As part of the general refurbishment this fire place may also be removed.

Photo 12 Soot Markings on Old Chimney. Flu may Need Liner if Chimney is to Continue in Use

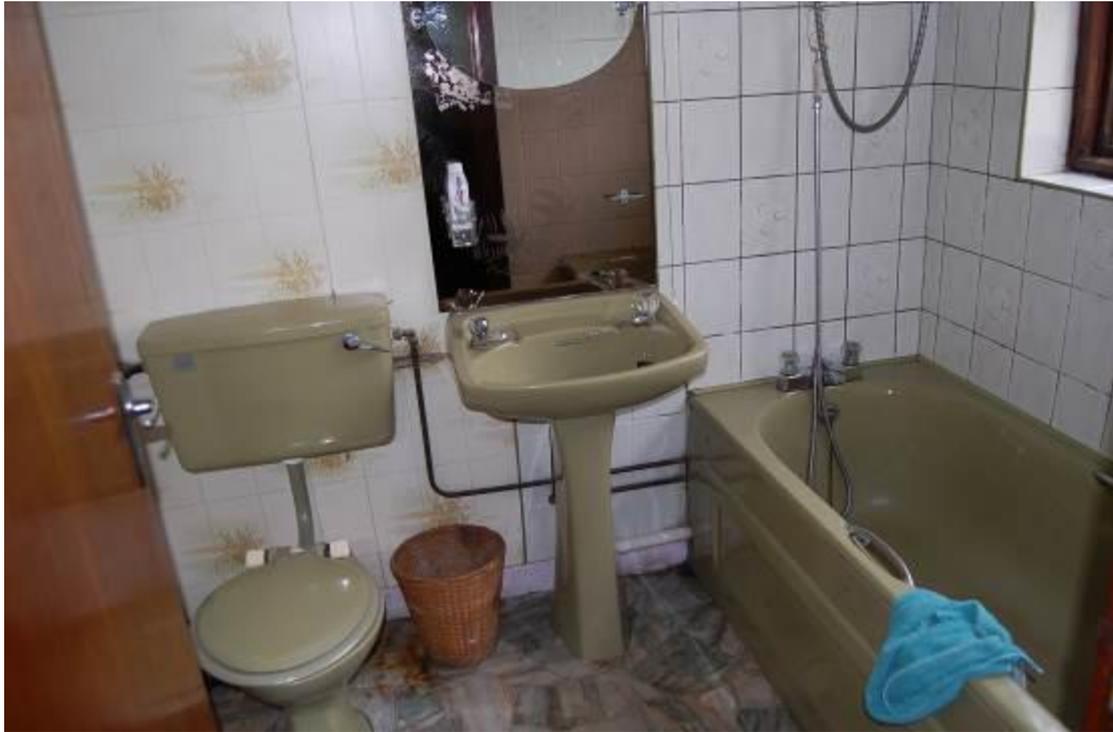
There is a whb, WC and bath in the bathroom on the first floor in the extension. While everything is working and there are no leaks evident the general condition is poor, old and dated. As part of a general refurbishment complete replacement of all sanitary ware is likely.

Photo 13 Poor Condition of Main Bathroom

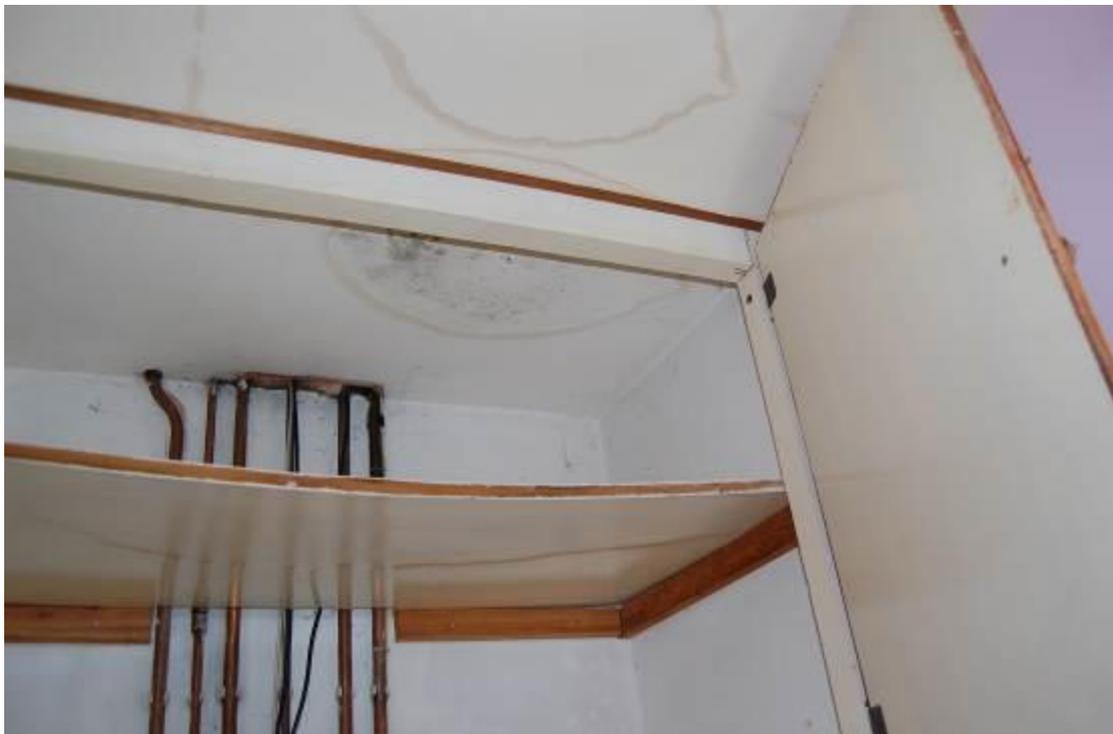
In bedroom 2 on the first floor there are some damp patches on the ceiling in the wardrobe. This is likely to have come from the water tank rather than any leak in the roof. Some minor leak may have occurred or it could have been caused by condensation on the un-insulated tank.

Photo 14 Damp Patch in Bedroom 2 Under Location of Attic Tank. Pipes going up into attic are not Insulated Above

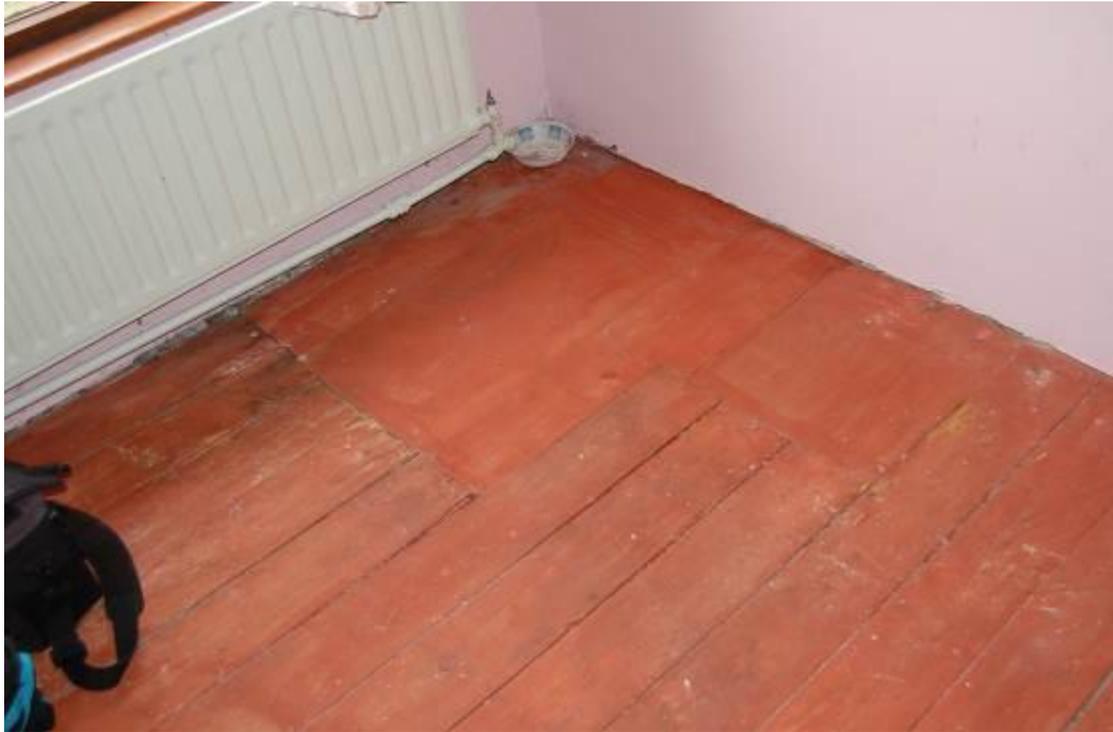
Photo 15 Patched Floor in Bedroom 4. Leaks from Heating Pipe may Have Damaged the Floor Joists

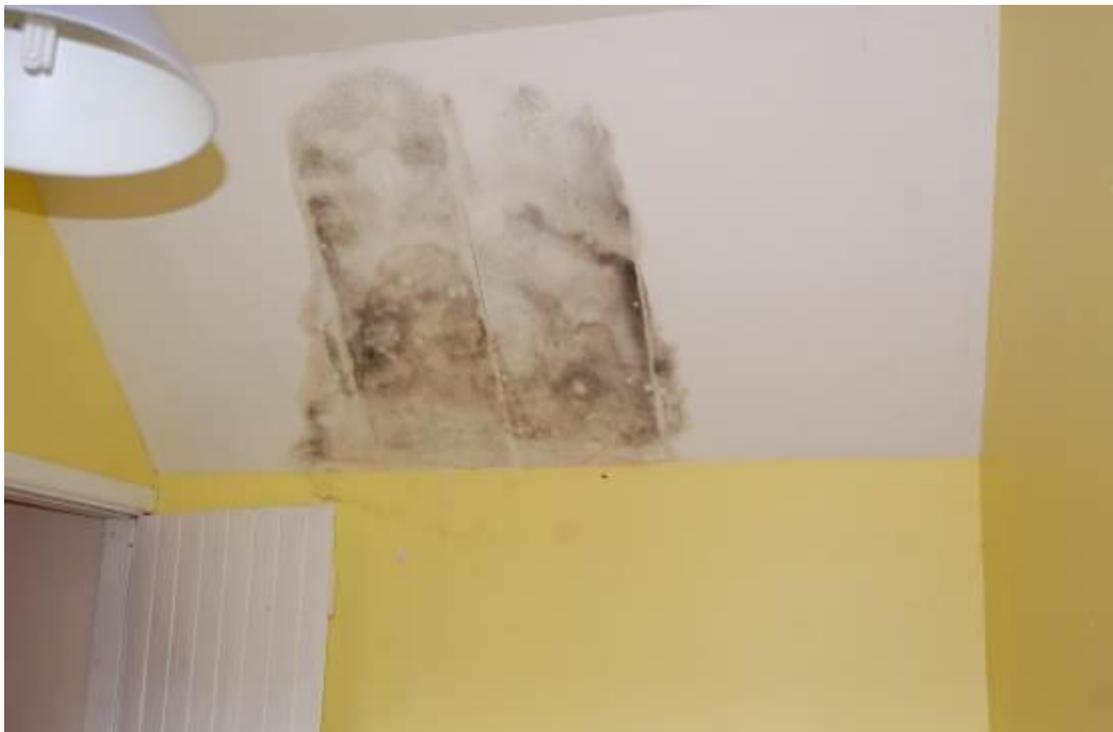
As referenced above at first floor level the ceiling in bedroom 6 at the gable end of the old part of the house is badly marked due to dampness. The cause of this has been identified as the damaged roof tiles and when the roof is repaired this section of the ceiling will dry out. It may be necessary to replace the ceiling after it dries out but it could also be ok to just redecorate.

Photo 16 Dampness on Ceiling Bedroom 6 Due to Damaged Roof Tiles Above

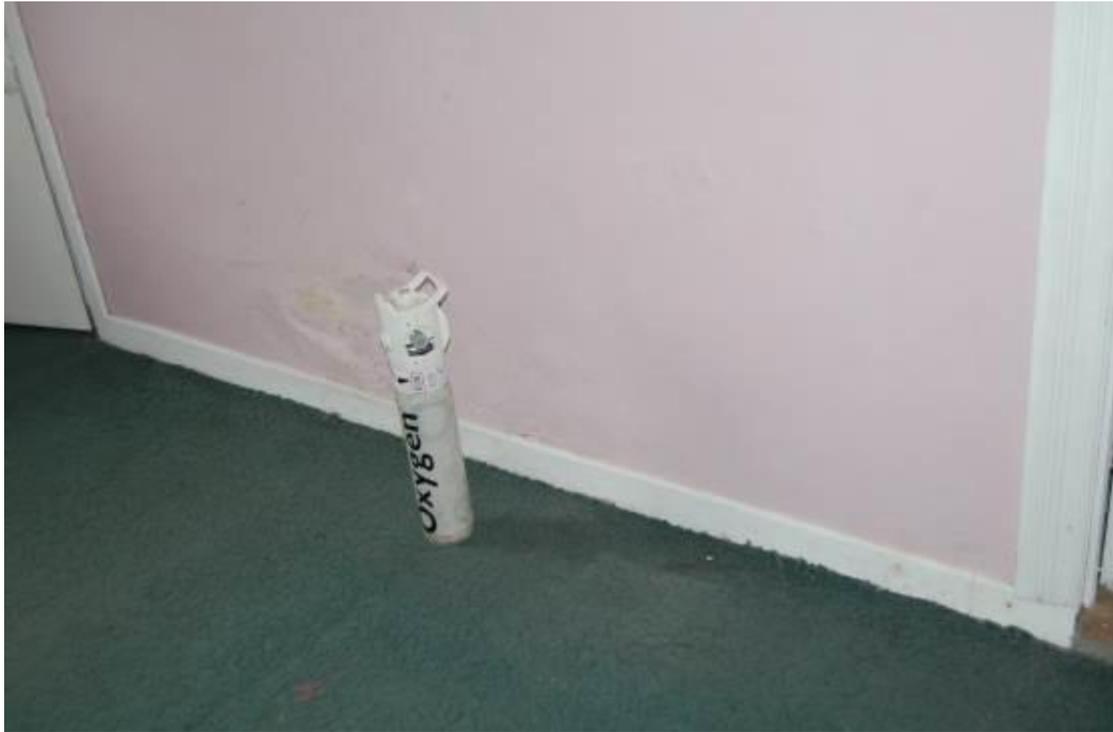
On the ground floor in the old part of the house (bedroom 1) there is some evidence of dampness at low level on the dividing wall at the back of the chimney breast. There is also dampness at ceiling level on the front wall and rear wall. The dampness looks minor and following, some repairs, making good and regular heat and use of the house, will most likely not be an ongoing issue.

Photo 17 Localised Damp in Bedroom 1 Ground Floor Old House

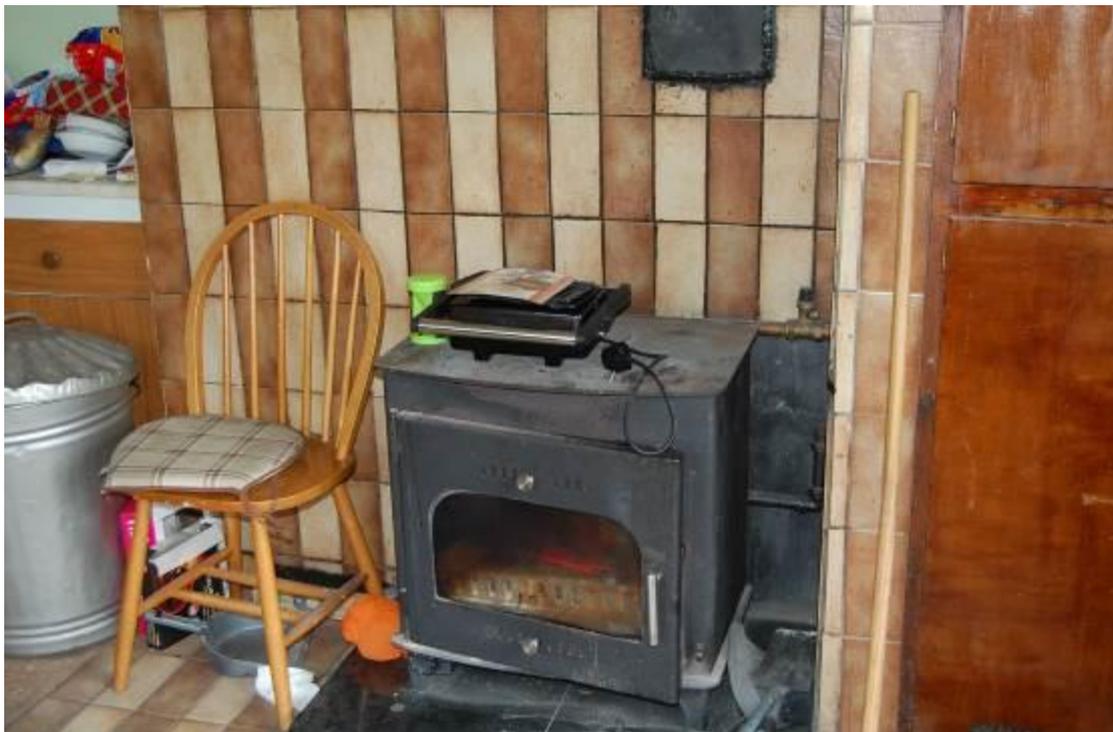
Photo 18 Solid Fuel Stove in Dining Room serves a Limited number of Radiators

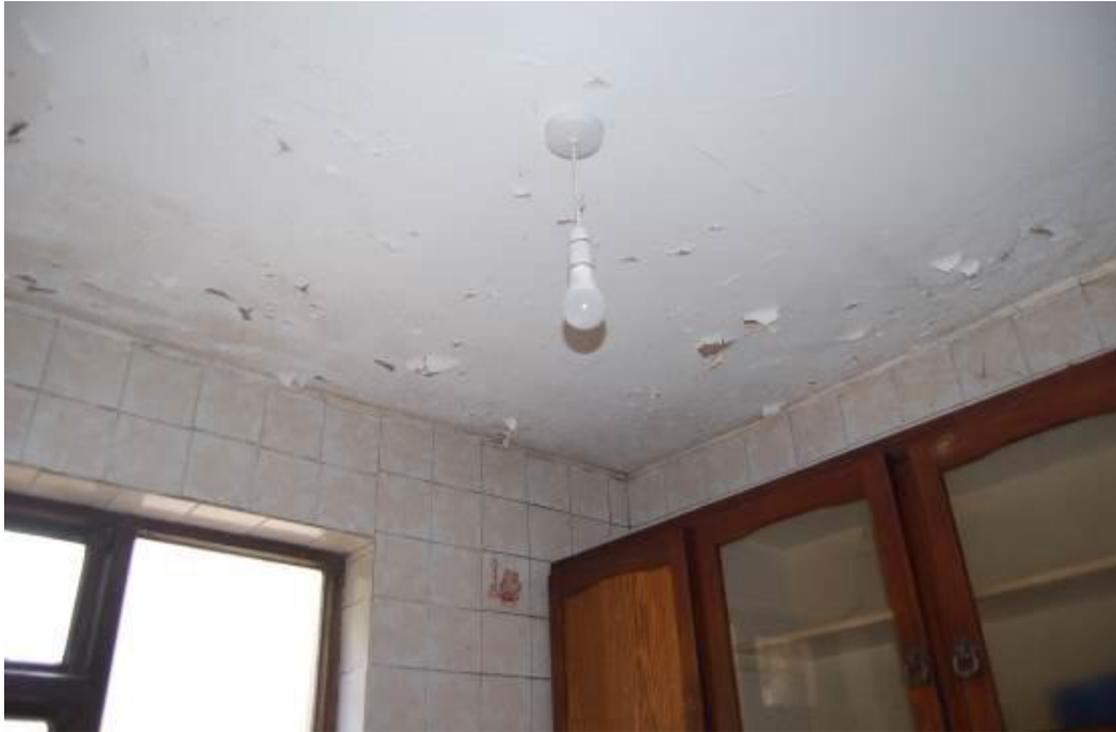
Realistically this property has no functioning kitchen and complete replacement is required. Given the size of the area of the existing kitchen it will either have to be moved into the larger dining area or an extension added. The ceiling of the existing kitchen is in poor state due to the lack of ventilation over the cooker and general lack of heat and use of the property.

Photo 19 Poor Condition of Kitchen Ceiling
